Manhole Inspection Summary

Manhole # S21G__017MH

Insp Date: **10/9/07 1:13 PM**

Location Address: **1908 VINE-FAYETTE**

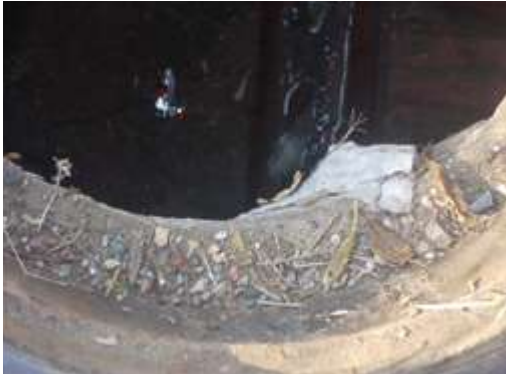
Defect 1

Frame Offset: **2** (in.) Condition: ☒ Sound ☐ Cracked ☐ Leaks

FRAME OFFSET

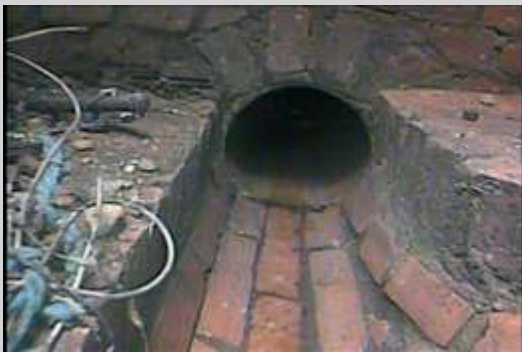
12 O'Clock Outflow

8 in. Circular Gravity Sewer
Pipe Out @ 12 O'Clock

Pipe Height: **8.4** (in.) Rod and Bar (Angled)
Pipe Material: **Clay** ☐ Pipe Lined
Invert Depth: **6.66** (ft.) Flow Characteristics: **Slow**
Deposits: ☒ None ☐ Mud ☐ Sludge ☐ **Debris** ☐ Grease
Silt Depth: (in.) Deposits Extent:
Infiltration: **None** Pipe Seal Cond: **Sound**

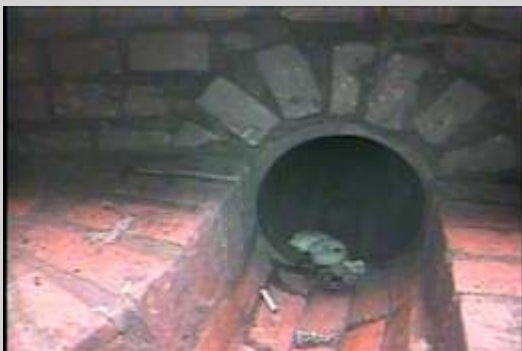
3 O'Clock Inflow

8 in. Circular Gravity Sewer
Pipe In @ 3 O'Clock

Pipe Height: **8.4** (in.) Rod and Bar (Angled)
Pipe Material: **Clay** ☐ Pipe Lined
Invert Depth: **6.17** (ft.) Flow Characteristics: **Slow**
Deposits: ☐ None ☐ Mud ☐ Sludge ☒ **Debris** ☐ Grease
Silt Depth: **1** (in.) Deposits Extent: **Light**
Infiltration: **None** Pipe Seal Cond: **Sound**

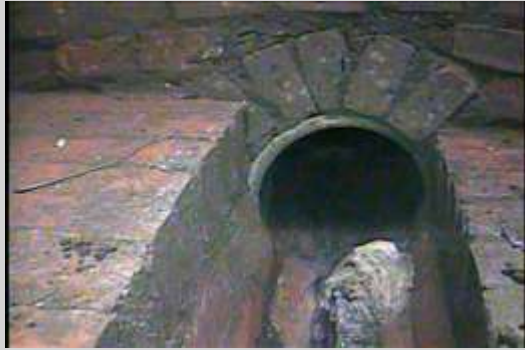
6 O'Clock Inflow

Pipe In @ 6 O'Clock

Deposits: ☐ None ☐ Mud ☐ Sludge ☒ **Debris** ☐ Grease

Silt Depth: **2** (in.) Deposits Extent: **Light**
